Liberia Maritime Authority

Marine Advisory: 04/2013

SUBJECT: BALLAST WATER EXCHANGE- HAZARDS AND PRECAUTIONS

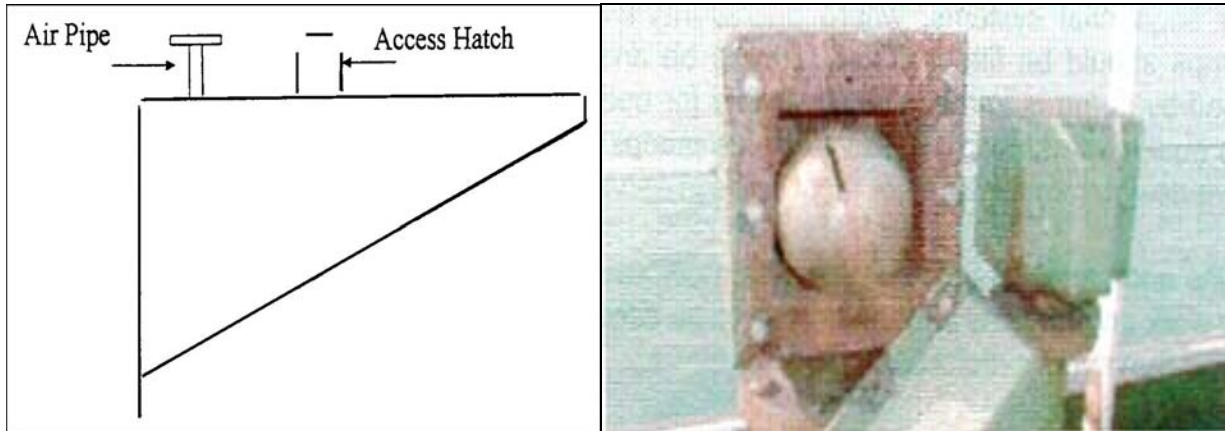
Additionally, certain watertight and weather-tight closures (Example: manholes) which may be opened during exchange, should be re-secured.

Location and construction of air-pipe and access hatch

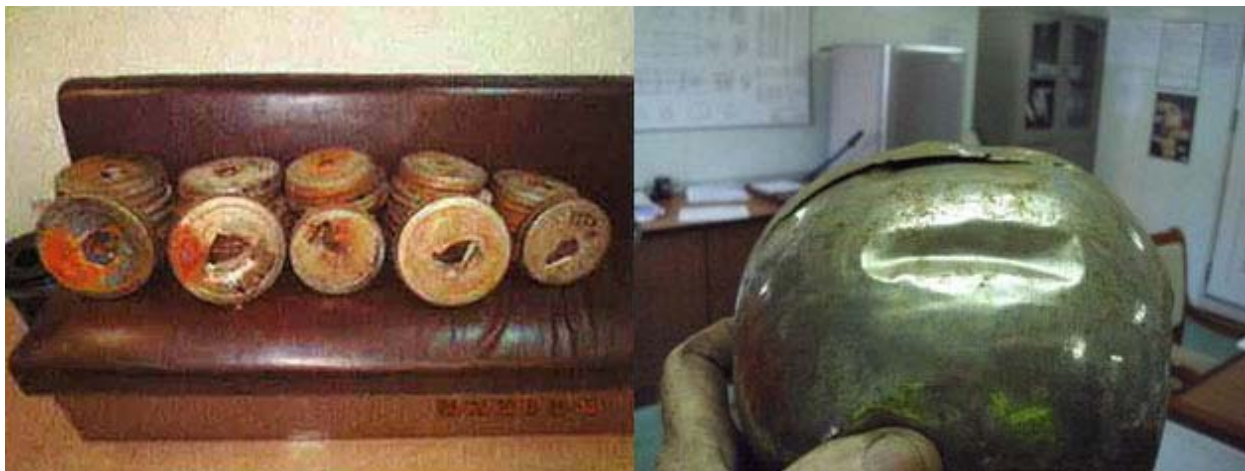
Recent port state control detentions (particularly in Australian waters) have revealed several cases of damages to air pipe heads. The air pipe heads were of the automatic float type, from different manufacturers and used by different new construction shipyards.

Investigation showed that all the air pipe heads had been damaged by being subjected to continuous overflow of the ballast tanks for ballast water exchange – Air-pipes are not designed for continuous ballast water overflow.

Damaged floating devices in air-pipes heads subjected to continuous overflow
