LIBERIA MARITIME AUTHORITY

Marine Advisory: 34/2024

Subject: Hazards Associated With Loading, Moving, and Storing Heavy Objects.

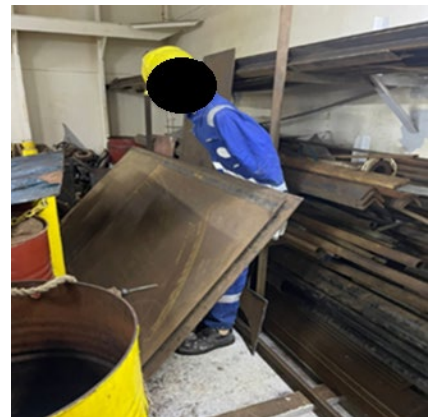
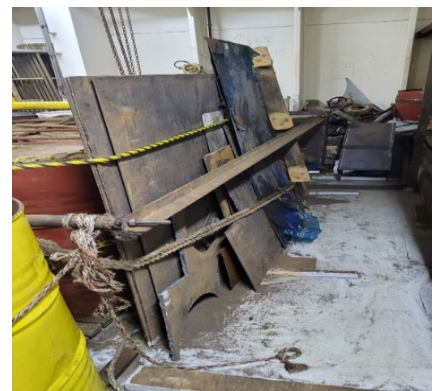
- The first case occurred while the vessel was moored in port. A toolbox meeting was held by the Chief Officer (C/O) and crew. The crew were then to retrieve steel plates that were kept in the steering gear room for a maintenance job.

- The trainee fitter went alone to the steering gear room and was later found unconscious, stuck between the steel plates and a steel shelf.
- The steel plates were usually secured by a locked steel bar connected to fixed steel rods on both ends of the lashing points and by two nuts. Both nuts were removed and placed on a nearby drum allowing the steel plates to fall on the trainee fitter.

The Administration recommends owners, operators, masters, and the crew on Liberian flag vessels to review and amend as necessary their onboard safety training procedures developed in compliance with Part 7 of the ISM Code and paragraph 3.3.3 (c) of Liberian Marine Notice MLC-005 to ensure that masters and crew onboard receive training concerning the hazards associated with loading, moving, and storing heavy objects and equipment, which could potentially be hazardous to seafarer's health. A formal and thorough risk assessment must be conducted before loading, moving, and storing heavy objects and equipment. Additionally, a work permit should be considered to be added to the "company's operational procedures" as described in part 4 of the ILO Code of Practice, "Accident Prevention on Board Ships at Sea and in Port."

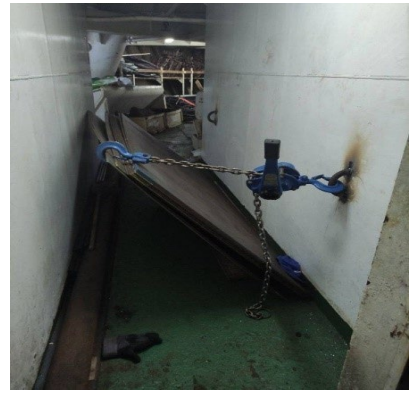
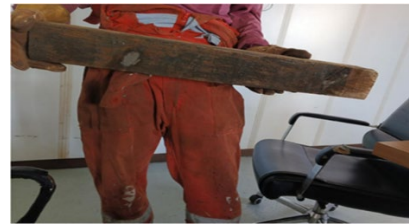
the plates slightly inclined vertically, with the upper edge resting on the passageway wall, before strapping them with a latching belt. Moving the steel plates was carried out successfully until the ninth (9th) plate.

- After the eighth (8th) plate was moved and before a coffee break, the Bosun secured the plates with the latching belt and added a wooden block across to the other side of the passageway. Upon returning from the coffee break, the Bosun removed the wooden block and latching belt while the rest of the crew moved the ninth (9th) plate.
- The steel plates then fell towards the Bosun and crushed his chest, resulting in the fatal injuries.

The investigations noted a lack of full awareness of the hazards associated with loading, moving, and storing heavy objects and equipment without taking necessary precautions before an operation/activity commences.
