Marine Advisory: 39/2024

Subject: Electrical Plant's Restoration Procedures

Safety Alert 10-24

DON'T GET CAUGHT IN THE DARK: KNOW YOUR ELECTRICAL PLANT'S RESTORATION PROCEDURES!

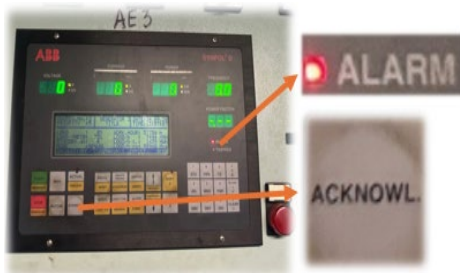
Figure 1 - Generator Control Panel

In this case, a non-audible alarm at the generator control panel required acknowledgement before the ship service generators could be restarted. This alarm was not integrated within the ship's machinery monitoring system, causing it to be easily overlooked. The crew's unfamiliarity with the control panel delayed their ability to identify and acknowledge this alarm, prolonging the restoration of the main power supply. The Coast Guard strongly **recommends** that owners, operators, and vessel officers:

- Consider developing and implementing new Safety Management System procedures or evaluating the effectiveness of existing procedures relative to crew familiarity, training on electrical power systems, and emergency procedures, including restoring the ship's main power supply following a loss of power.
- Train crew members on the proper steps for restoring the electrical plant to minimize response times during blackouts.
- Conduct blackout and reset drills under safe operating conditions to ensure emergency procedures are effectively applied.
