Liberia Maritime Authority

Marine Advisory: 04/2013

SUBJECT: BALLAST WATER EXCHANGE- HAZARDS AND PRECAUTIONS

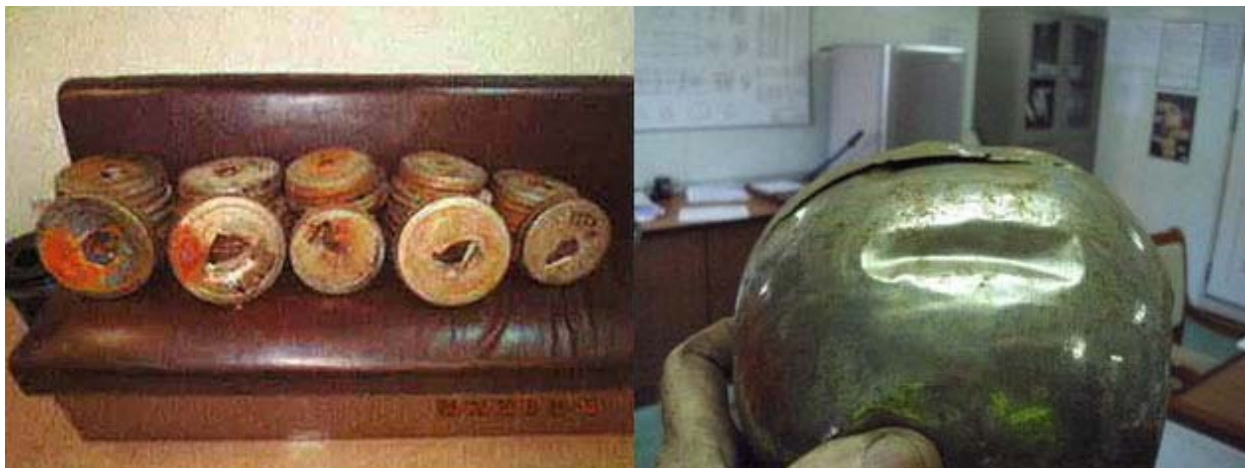
Recent port state control detentions (particularly in Australian waters) have revealed several cases of damages to air pipe heads. The air pipe heads were of the automatic float type, from different manufacturers and used by different new construction shipyards.

Investigation showed that all the air pipe heads had been damaged by being subjected to continuous overflow of the ballast tanks for ballast water exchange – Air-pipes are not designed for continuous ballast water overflow.

Damaged floating devices in air-pipes heads subjected to continuous overflow
