Liberia Maritime Authority

Marine Advisory: 04/2013

SUBJECT: BALLAST WATER EXCHANGE- HAZARDS AND PRECAUTIONS

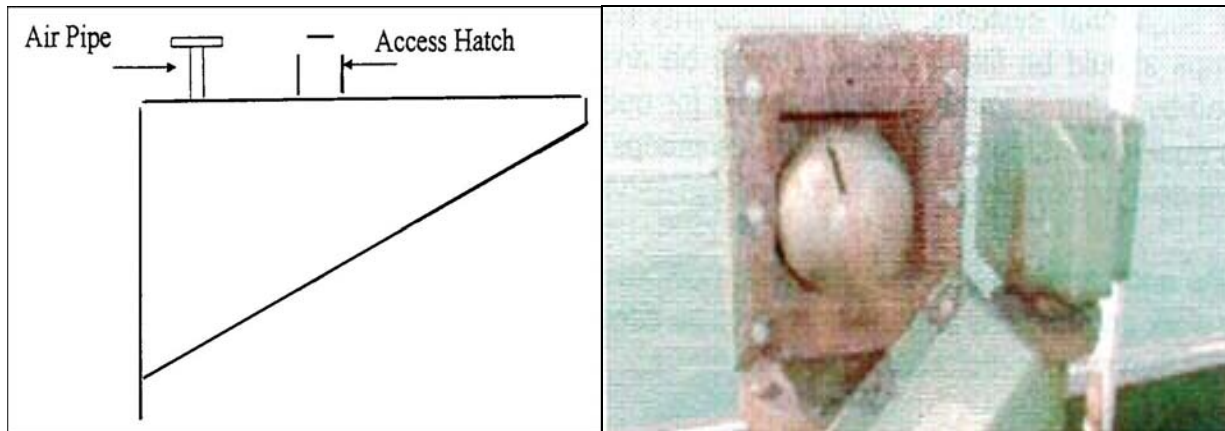
Location and construction of air-pipe and access hatch

Additionally, certain watertight and weather-tight closures (Example: manholes) which may be opened during exchange, should be re-secured.
